Fire Testing of fire protection gratings Type LHD (Appendices 1)

SP Technical Research Institute of Sweden

SP Technical Research Institute of Sweden Fire Research - Fire Dynamics

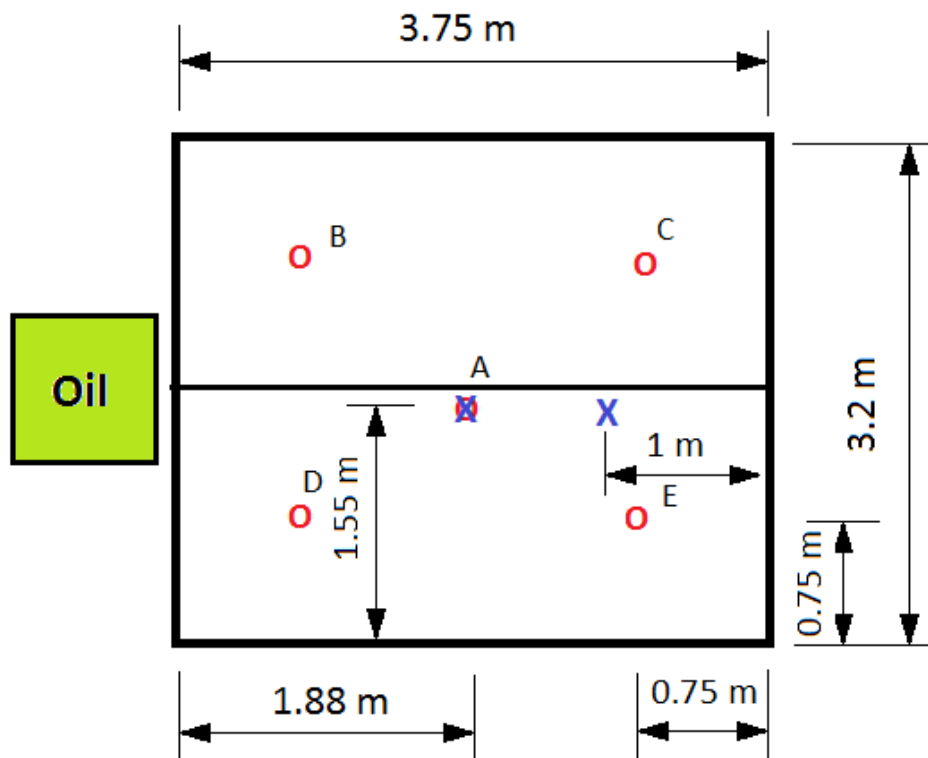
- **O** are the thermocouple trees, placed at the positions A-E.
- **X** are the locations of the gas sampling pipes, placed 10 cm below the fire protection gratings.

Figure 1. Top view of the experimental setup.

The transformer pit was 3.75 meters by 3.2 meters and 1 meter deep. The pit is built in concrete at PcPs facilities in Vildbjerg (Denmark) . During tests the oil was stored in a tippable cart with a total volume of 600 liters. Transformer oil used in the tests was the Nynas Transformer Oil – Nytro 10XN. Technical data sheet for the oil is attached in Appendix 1. Sketches and photo of transformer pit and placement of measuring instruments are presented in Figure 1 to 3. The temperature measurement was conducted with five thermocouple piles. The thermocouple piles are named A-E and their location are shown in Figure 1. Each pile contained six thermocouples at 1, 20, 50, 75, 90 and 130 cm above the ground level. Fire protection gratings were installed at 0.80 m from the ground, i.e. the thermocouples at 90 cm and 130 cm were located above the fire protection gratings. Gas sampling for O₂ analysis was conducted at two positions, at the center of the pit and at 1 m from the back end of the pit, as shown in Figures 1 and 2. The inlet of the gas sampling pipe was located 10 cm below the fire protection gratings. The symbols in the figures represents:

The temperature and oxygen concentration measurements from both tests correspond well. The results from second test are presented in this report. The results for the gas temperature measured by all thermocouple piles (A-E), positioned according to Figure 1, are shown in Figures 16, 17, 18, 19 and 20. For all graphs the time-axis has been shifted so that $t = 0$ corresponds to the moment when the oil was started to be poured into the pit. The thermocouples installed at 1 cm height from the ground are became covered by the oil layer at the bottom of the pit, meaning that these thermocouples measure the liquid temperature of the oil. The instant temperature increase after tipping the burning oil into the pit is followed by a rapid drop in temperature. Within 60 seconds the temperatures at all positions have stabilized at approximately 100 °C or lower. The temperatures below the protection gratings decay more slowly and fluctuate more than the temperatures above the protection gratings. This is due to the close proximity to the heated oil.

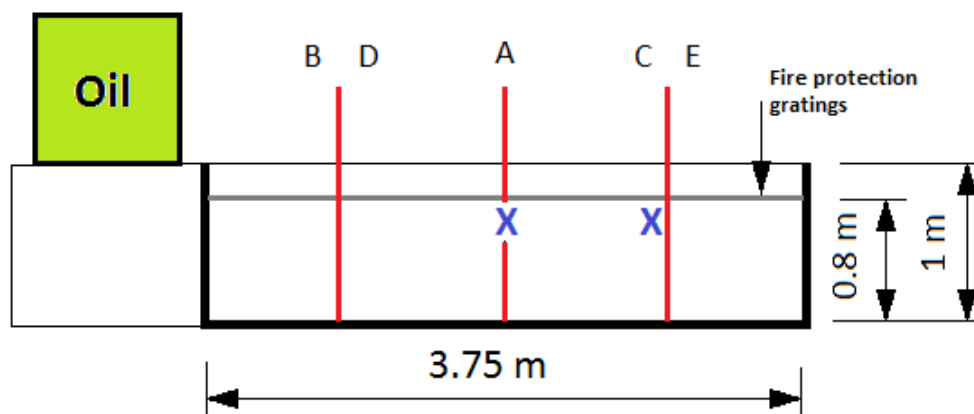
Figure 2. Side view of the experimental setup.

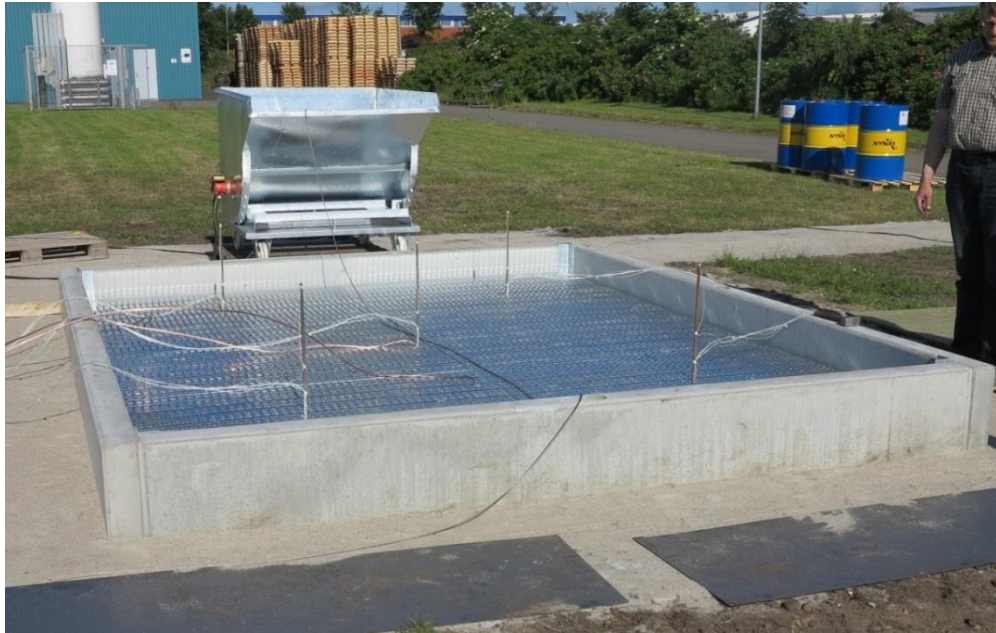
Figure 3. Photo of the test setup.

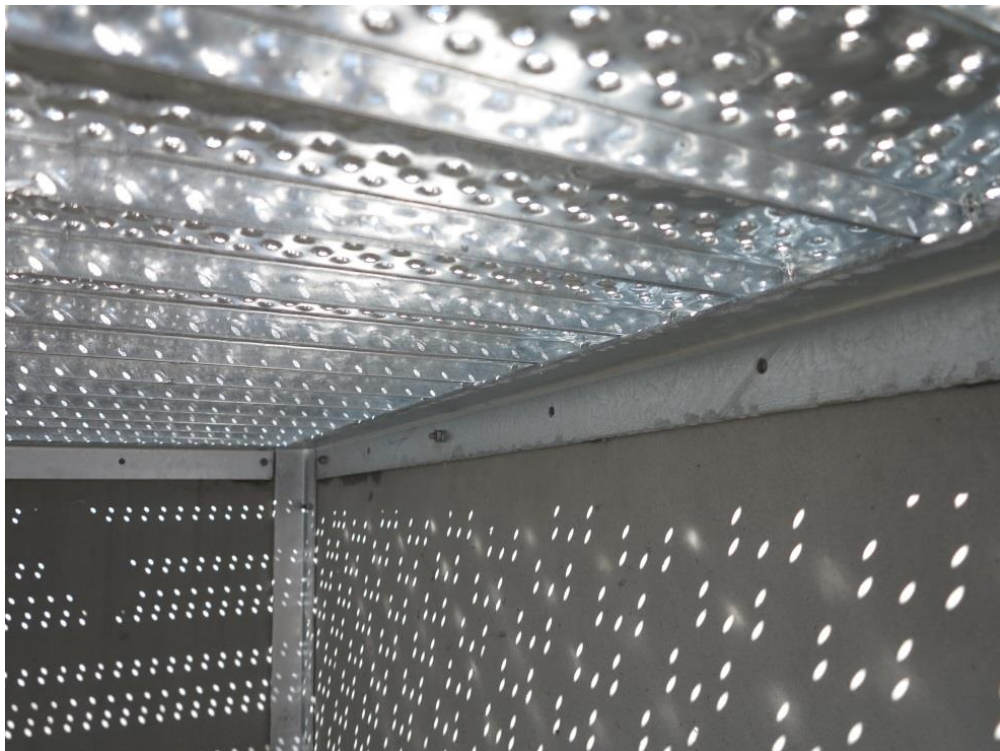
Figure 4. Fire protection gratings resting on angle bars.

The fire protection gratings were placed resting 80 cm from the ground level between angle bars installed on the pit inner frame and I-beam (HEB 140) placed in the middle of the longitudinal direction of the longest side of the pit as shown in Figure 4 and Figure 5.

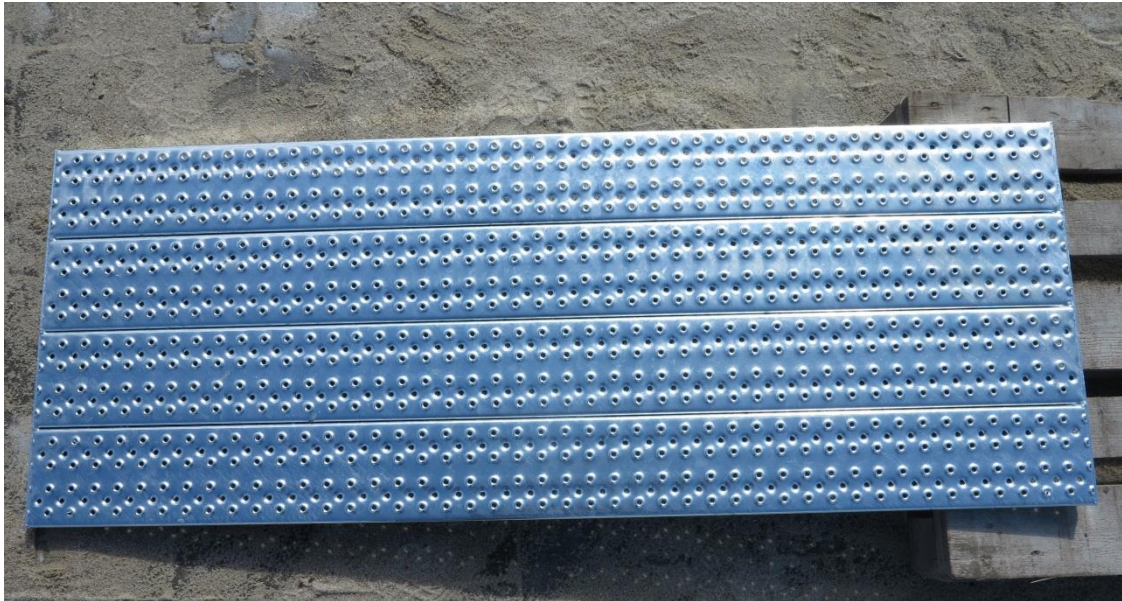
Figure 7. PcP. fire protection grating board.

Figure 7 shows a photo of a single grating board. It is manufactured from hot-galvanised sheet-metal. Four individual 3 mm thick sheet steel panels are welded together to form a grating board. The board has perforated surface structure. According to the manufacturer, the perforation ratio is about 4.1 % of the total surface. Each panel consists of six rows of holes, shown in Figure 7. Four of the rows are punched in the way that they form a shape of upward cone and remaining two rows are punched in the way that they form a shape of downward cone, shown in Figure 8. The holes have a diameter of 8 mm and are distributed on a centered rectangular lattice with nearest neighbor distance 25.5 mm and next nearest neighbor distance 36 mm, seen in Figure 9.

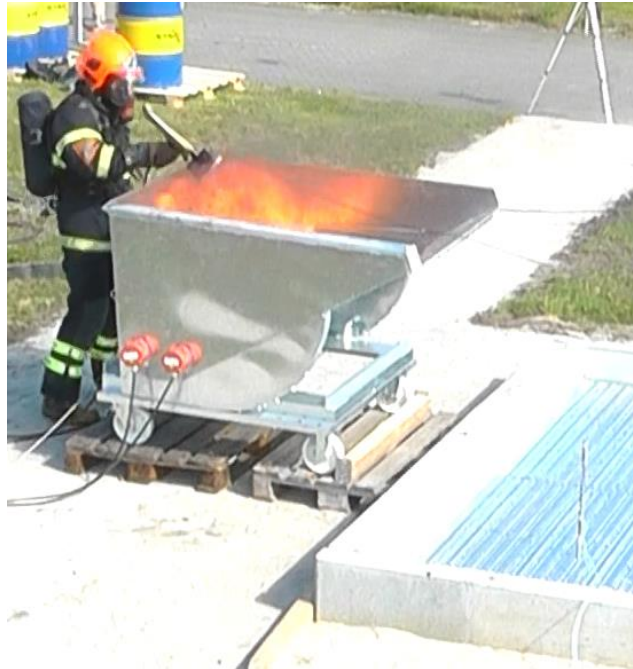
Figure 10. Ignition of the oil.

The test was performed two times - both times under same conditions. Each test started with filling the tippable trailer with 370 liter transformer oil, the amount that corresponds to depth of 3 cm for the pit used in the test. The oil was then heated with an electric heater combined with external gas burners. When the temperature of 90 ° C was reached, the oil was ignited with a gas burner as shown in Figure 11. After 1:30 (min:sec) pre-burn time the oil was tipped into the transformer pit. Figure 11 shows the burning oil before tipping the oil into the pit. Figure 12 shows the sequence when the oil is tipped into the transformer pit.

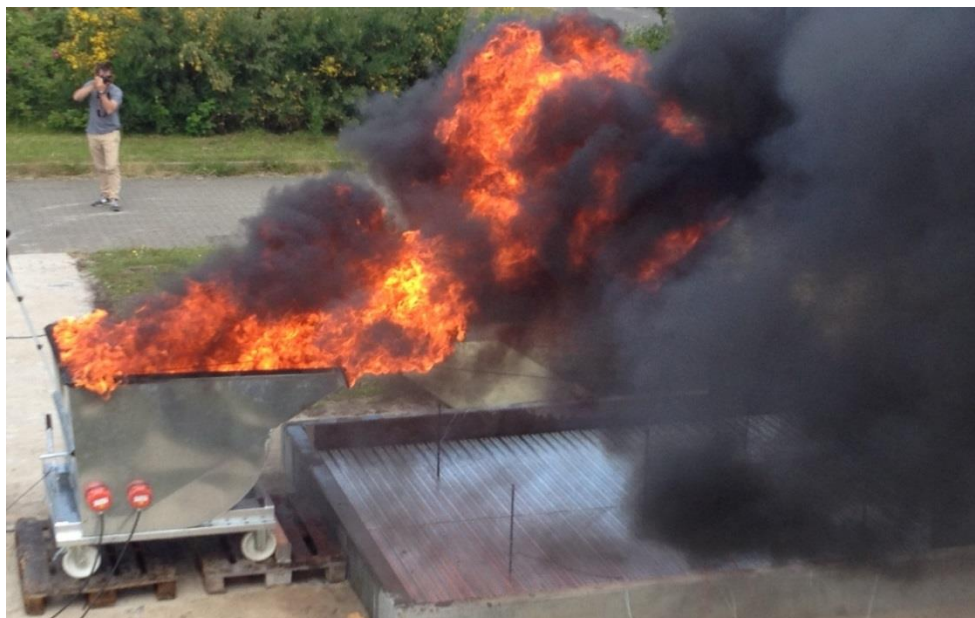
Figure 11. Burning oil before tipping.

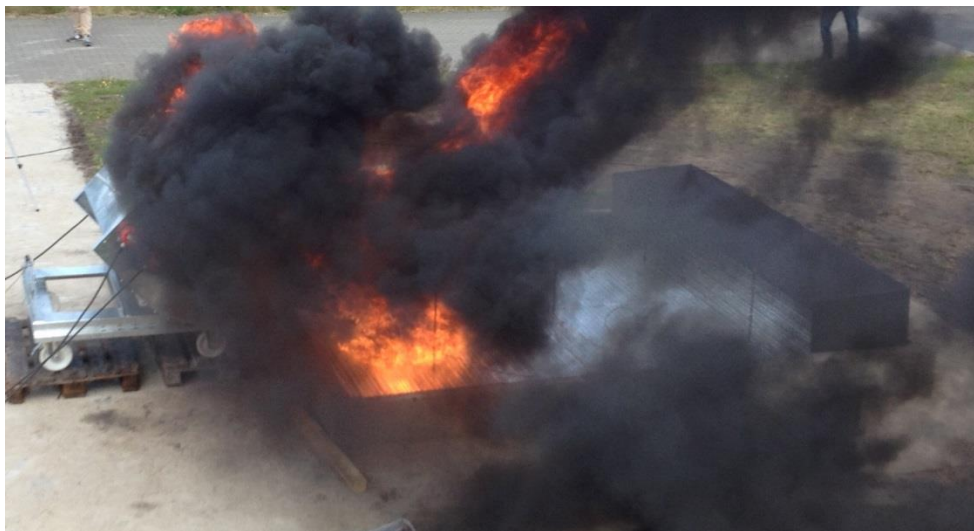
Figure 12. Tipping the burning oil into the pit.

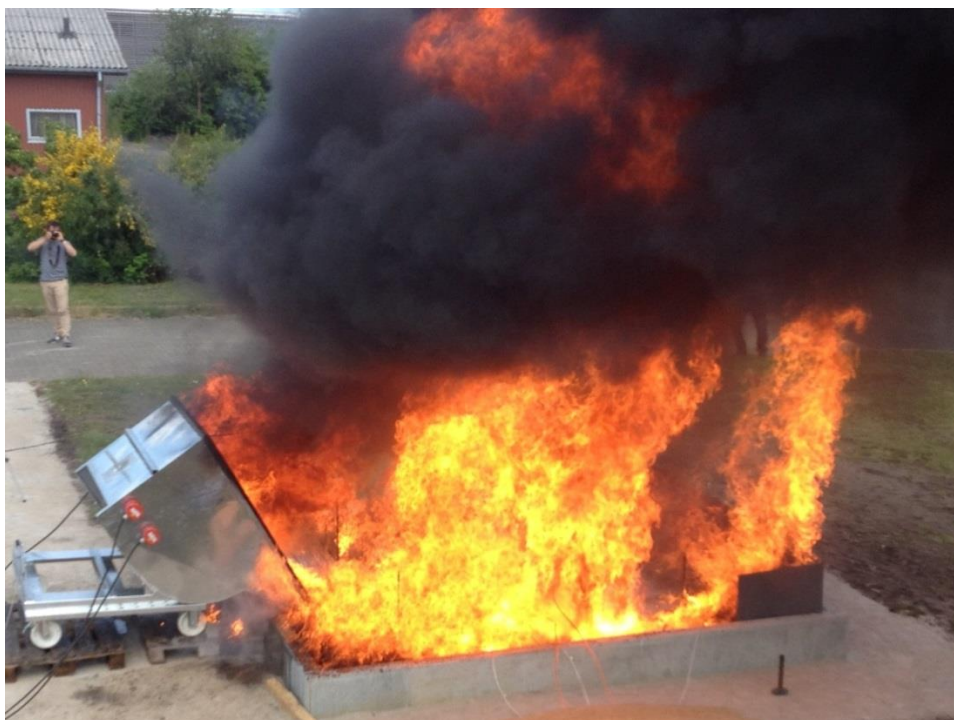
Figure 13. High intensity of the flames after tipping the burning oil into the pit.

A sequence of photographs taken during the test is shown in Figures 13, 14 and 15. Figure 13 shows the high intensity of the flames when the oil was poured into the transformer pit. The intensity of the flames decreased significantly as soon as all of the oil penetrated the cavities of the fire protection gratings, as seen in Figure 14. Complete flameout, shown in Figure 15, occurred approximately 6 seconds after the start of tipping the oil into the pit. Similar visual observations were made in both tests.

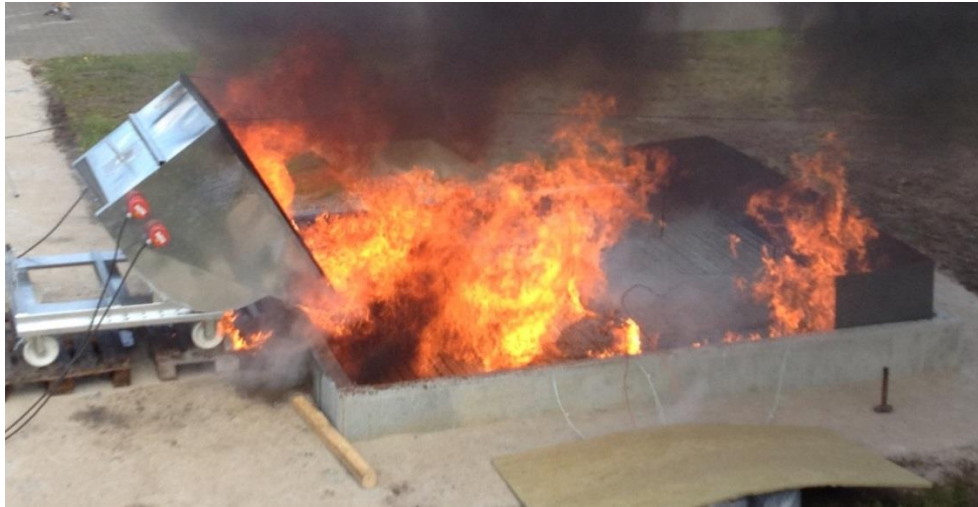
Figure 14. Flames were visibly smaller within a few seconds after tipping the burning oil into the pit.

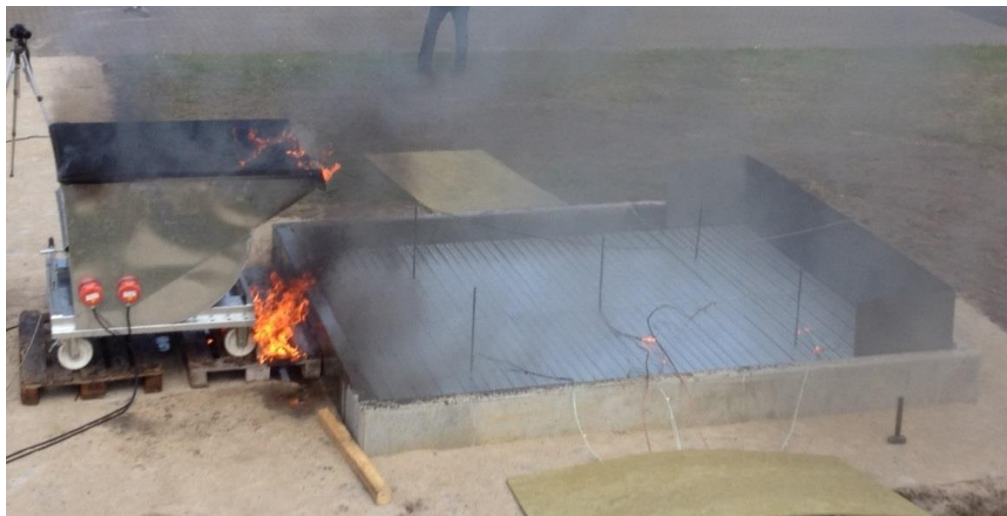
Figure 15. All visible flames disappeared approximately 6 seconds after tipping the burning oil into the pit.

The fire protection gratings Type LHD managed to successfully extinguish the fire during the performed tests. Complete flameout above the fire protection gratings occurred within 6 seconds under the conditions tested. Shortly after, the temperature and oxygen concentration measurements indicate that the fire was extinguished in the entire pit, also under the fire protection gratings.

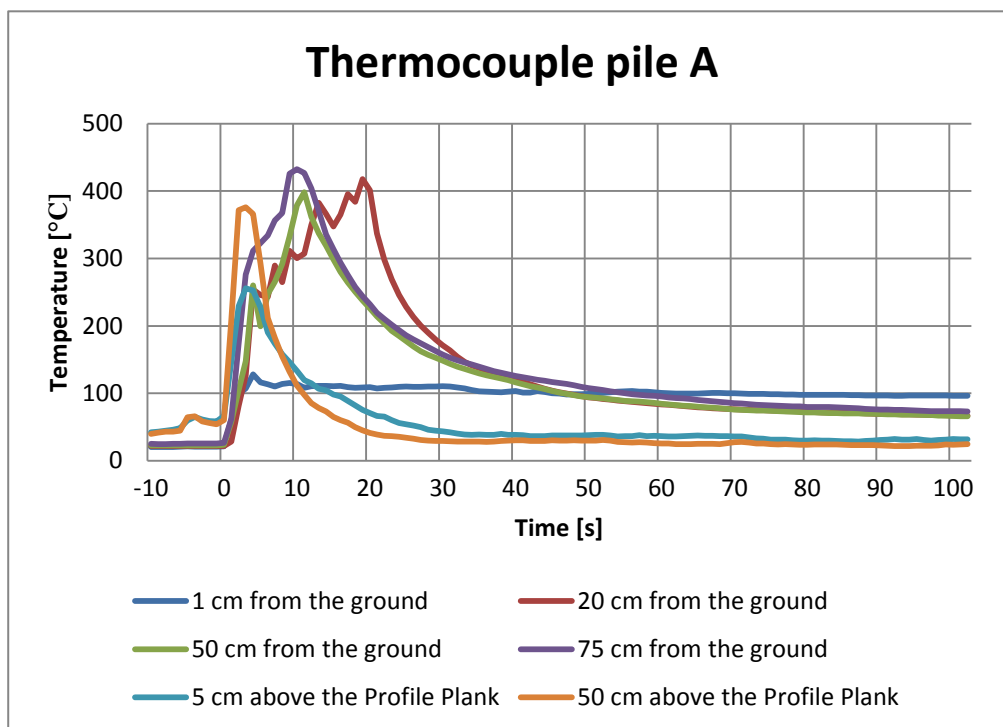
Figure 16. Gas temperature measured in the thermocouple pile A.

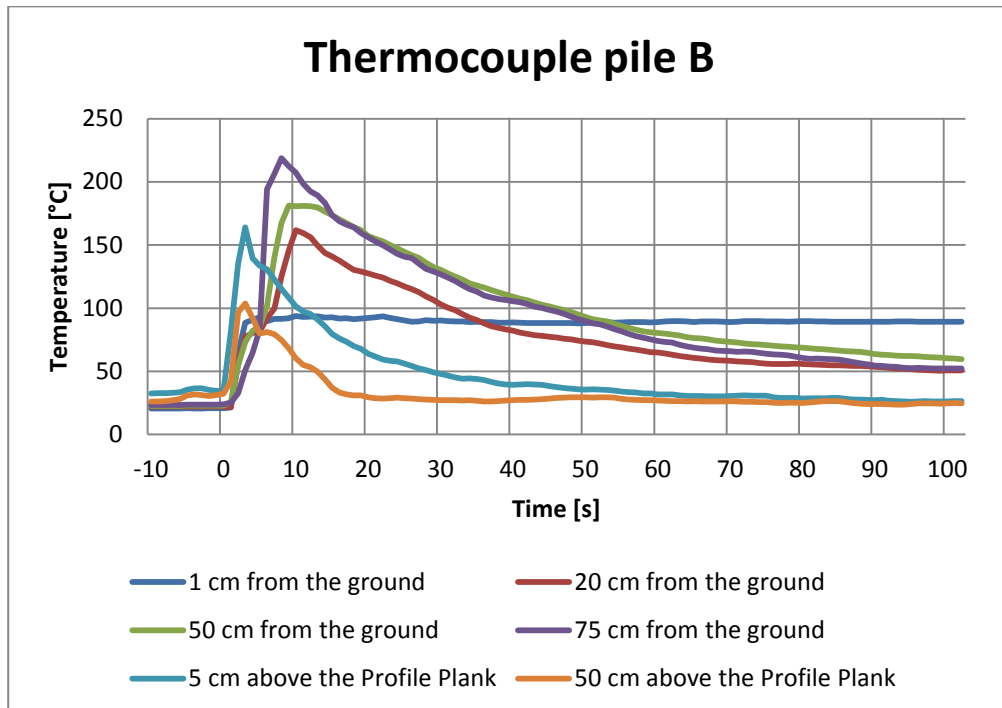
Figure 17. Gas temperature measured in the thermocouple pile B.

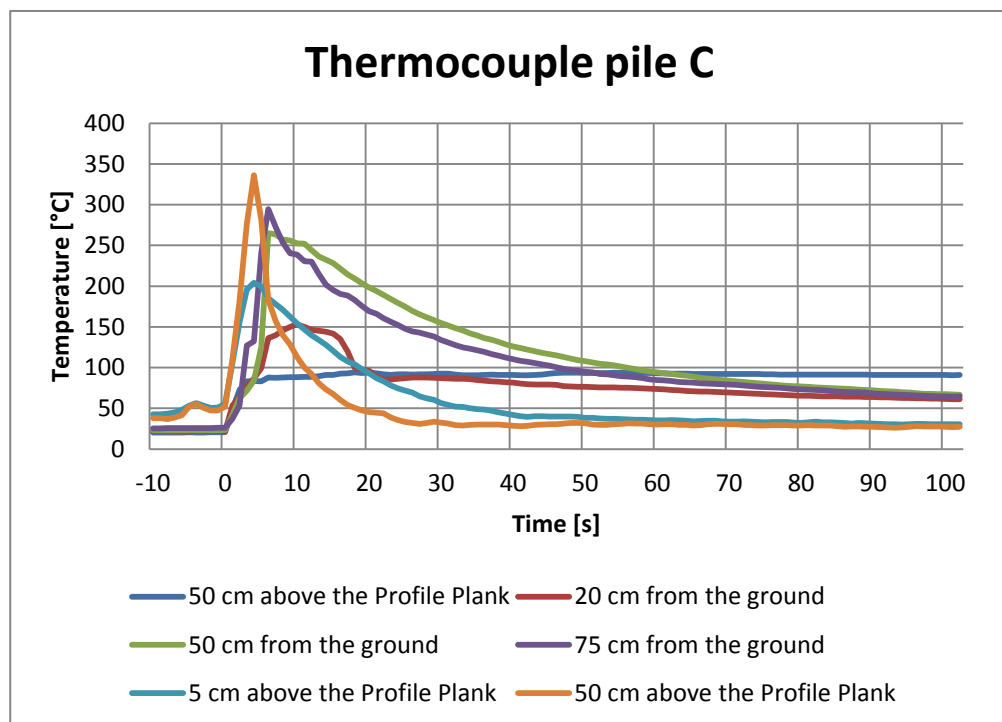
Figure 18. Gas temperature measured in the thermocouple pile C.

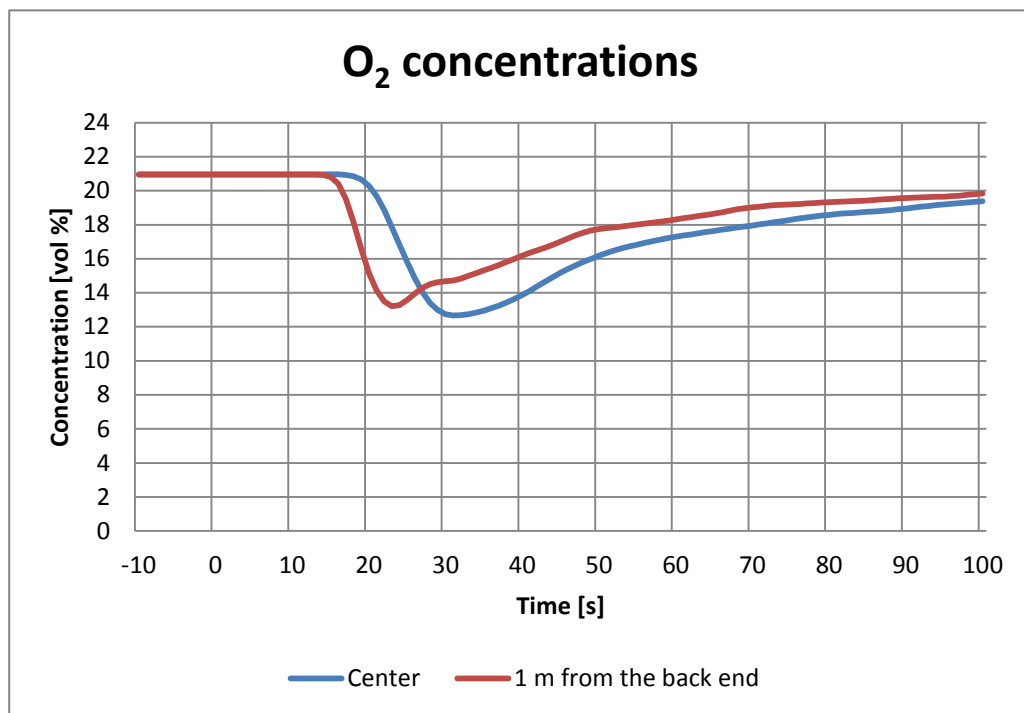
Figure 21. O₂ concentrations measured at center of the pit and 1 m from the back end of the pit.

Gas concentrations at two positions during the test, at the center of the pit and 1 m from the back end of the pit, are shown in Figure 21.

The rapid quenching of the fire is partly due to the reduced oxygen concentration and it is therefore important that the fire grid protection is covering the complete pit and is fastened tight to the concrete wall to minimize leakage of air around the edge of the construction.
